Contract Review

Description of contract: Due to on going damage of tree root systems during utility workings in the area, we were requested by the contractor to assist the excavation process by utilising Vacuum Excavation techniques to expose the root system with out damage to enable the utility works to progress

Vacuum Excavation in Tree Root Protection Zones

VACUUM EXCAVATION

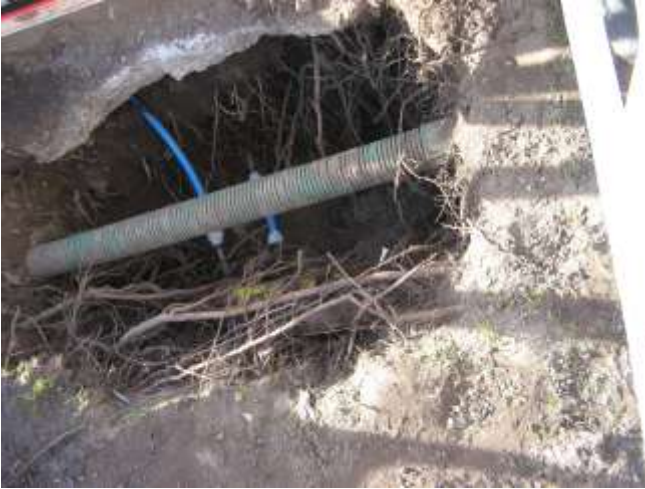
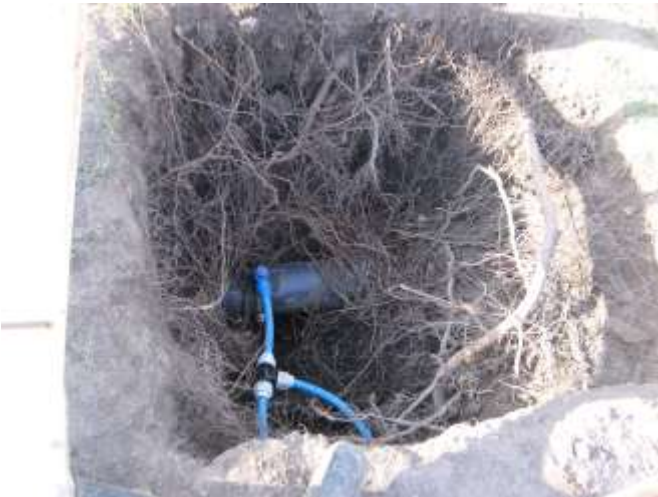
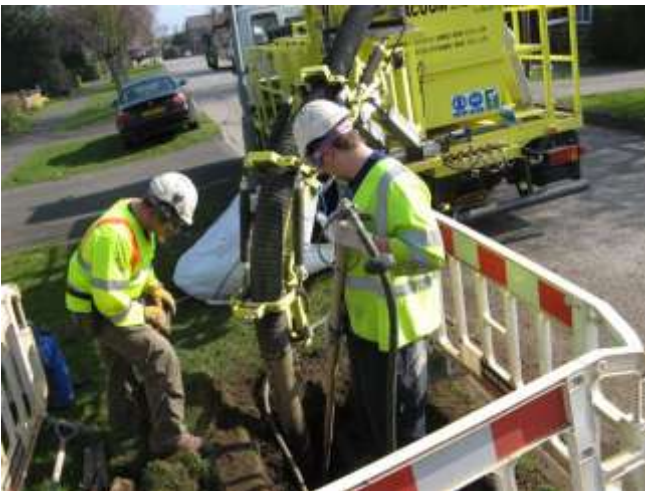
Photos:

The water main was exposed, together with the root systems of eighty years old mature lime trees, which remained intact, with minimal damage. It was then possible, with care that was usually forthcoming from the Utility Contractors, to work between the exposed roots to access and remake junctions on the water main, again with minimal damage to the roots. Moreover, pits that were to be open for more than a short time were sheeted over by your team, to prevent desiccation or freezing of the exposed roots, something that happens all too quickly, especially in warm, windy weather or frosty conditions. This was a nice piece of attention to detail that showed your team knew why they were doing what they were doing.
